TECHNICAL ASSISTANCE TEAM FOR EMERGENCY RESPONSE REMOVAL AND PREVENTION
EPA CONTRACT 68-01-7367

TAT-05-G2-01949

RE: Hendershot and Smith, Inc., Wickliffe, Ohio
TDD# 5-9004-18

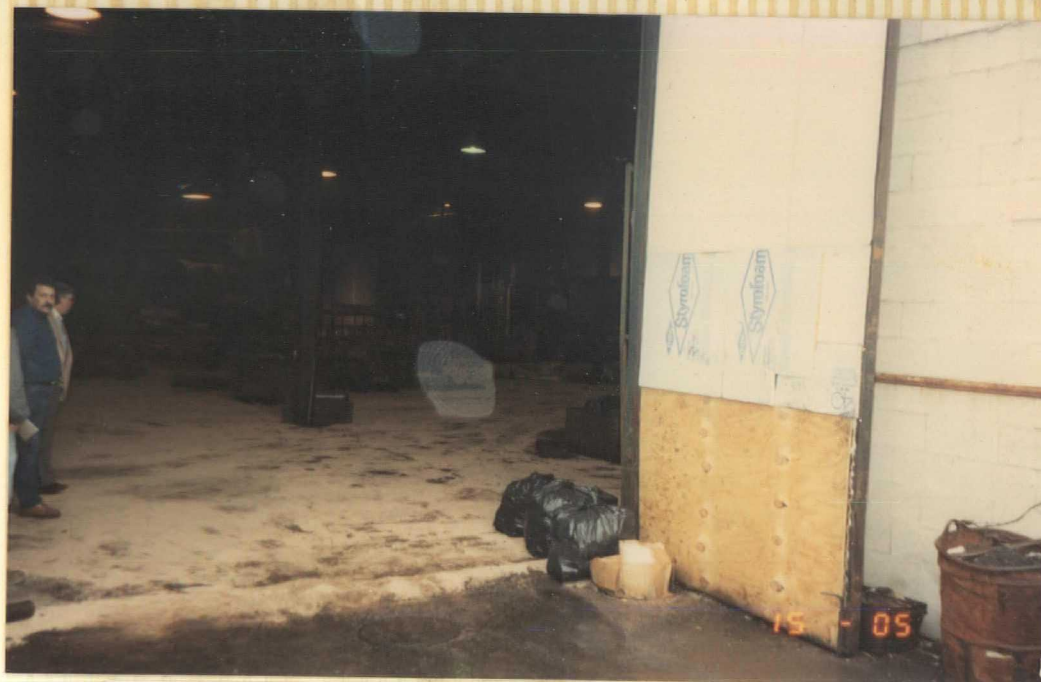
PHOTO: 3
 ROLL/PICTURE: 1/1
 SITE NAME: HENDERSHOT & SMITH, INC.
 DESCRIPTION: ENTRANCE TO HEAT TREATING FACILITY: FLOOR, DRAINS, ABSORBENT, MACHINERY, PERSONNEL
 DATE/TIME: 4-20-90 / 1400
 PHOTOGRAPHER: DOOLEY ~D.
 FILM: 35mm, 200 ASA, NO ATTACHMENTS

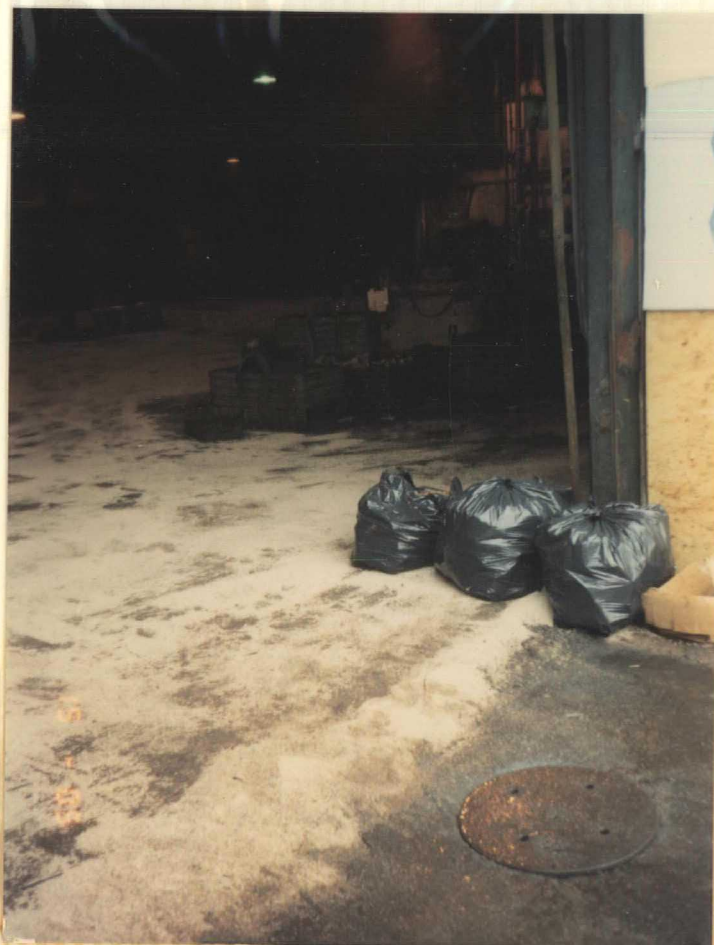
PHOTO: 4
 ROLL/PICTURE: 1/2
 SITE NAME: HENDERSHOT & SMITH, INC.
 DESCRIPTION: ENTRANCE TO HEAT TREATING FACILITY, ABSORBENT DIKE, DRAIN, MACHINERY.
 DATE/TIME: 4-20-90 / 1400
 PHOTOGRAPHER: DOOLEY ~D.
 FILM: 35mm, 200 ASA, NO ATTACHMENTS

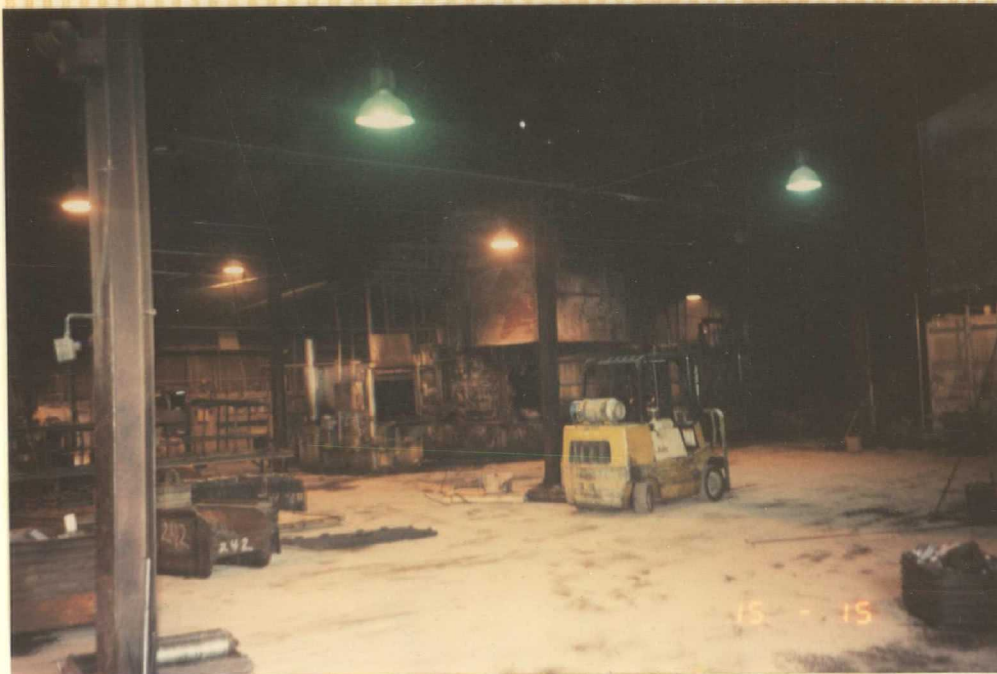
PHOTO: 5
 ROLL/PICTURE: 1/5
 SITE NAME: HENDERSHOT & SMITH, INC.
 DESCRIPTION: DAMAGED MACHINERY - SITE OF SECOND SPILL
 AND FIRE, ABSORBENT, EQUIPMENT.
 DATE/TIME: 4-20-90 / 1415
 PHOTOGRAPHER: DOOLEY D
 FILM: 35MM, 200 ASA, NO ATTACHMENTS

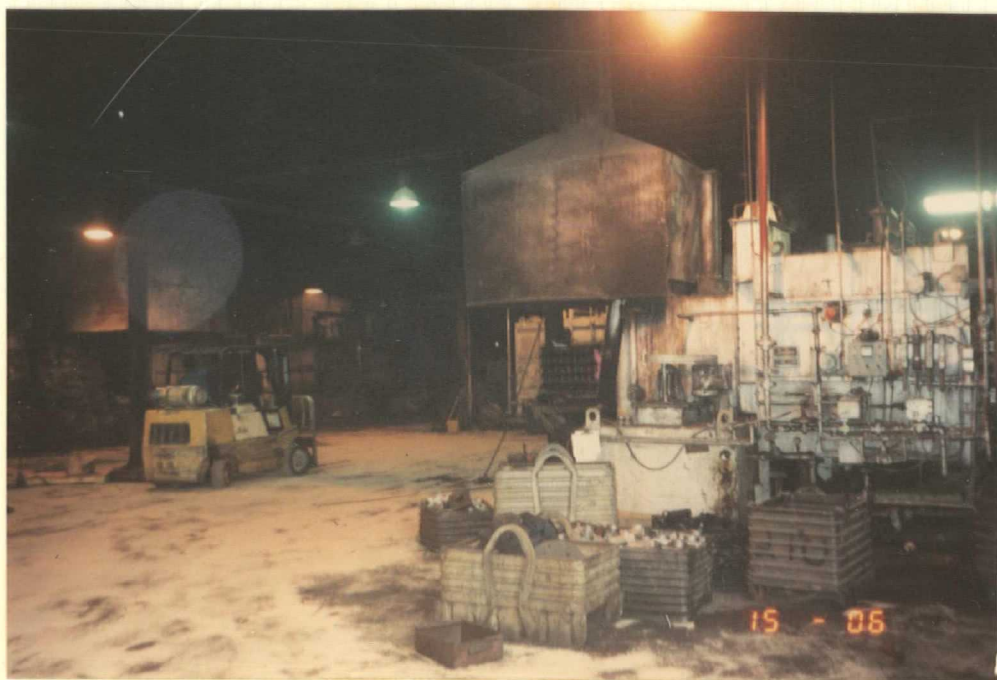
PHOTO: 6
 ROLL/PICTURE: 1/4
 SITE NAME: HENDERSHOT & SMITH, INC.
 DESCRIPTION: OPERATIONAL HEAT TREATING FURNACE,
 EQUIPMENT, ABSORBENT, PERSONNEL.
 DATE/TIME: 4-20-90 / 1415
 PHOTOGRAPHER: DOOLEY D
 FILM: 35MM, 200 ASA, NO ATTACHMENTS

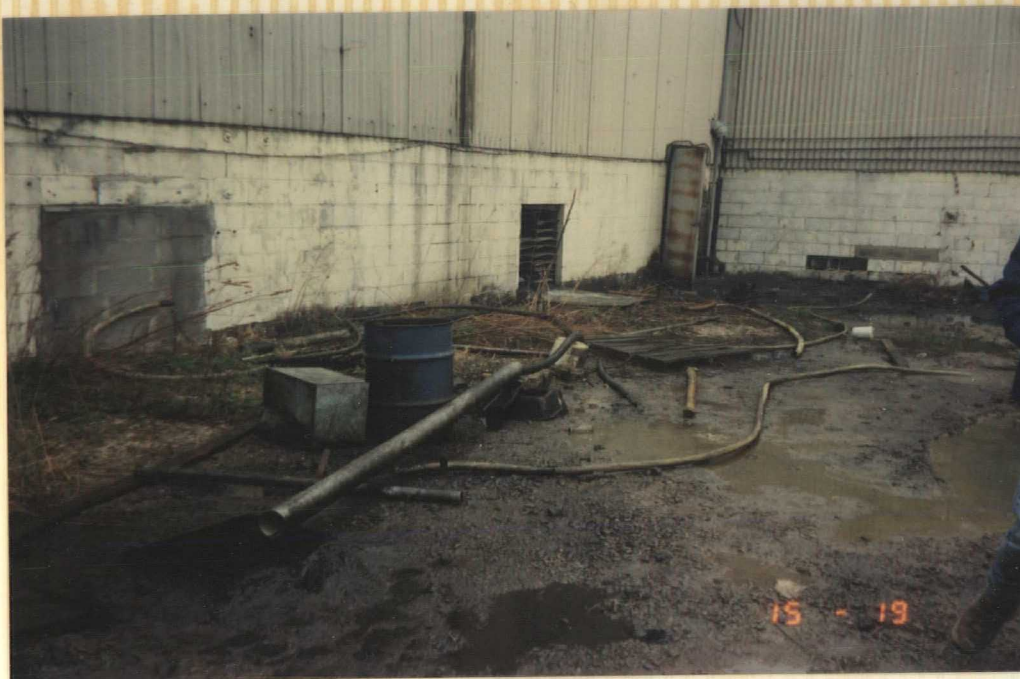
PHOTO: 7
 ROLL/PICTURE: 1/6
 SITE NAME: HENDERSHOT & SMITH, INC.
 DESCRIPTION: HEAT TREATMENT QUENCH OIL DISCHARGE OUTLET
 AND OPENING TO UNDERGROUND STORAGE TANK.
 DATE/TIME: 4-20-90 / 1420
 PHOTOGRAPHER: DOOLEY *ND*
 FILM: 35MM, 200 ASA, NO ATTACHMENTS

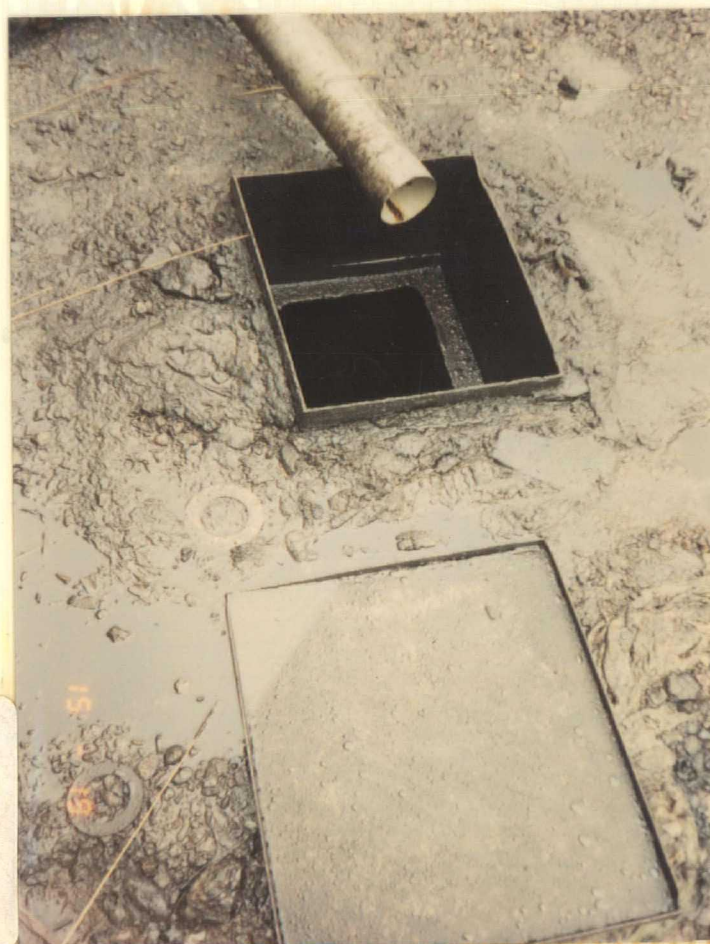
PHOTO: 8
 ROLL/PICTURE: 1/7
 SITE NAME: HENDERSHOT & SMITH, INC.
 DESCRIPTION: HEAT TREATMENT QUENCH OIL DISCHARGE
 OUTLET, UST OPENING, OIL SOAKED GROUND.
 DATE/TIME: 4-20-90 / 1425
 PHOTOGRAPHER: DOOLEY *ND*
 FILM: 35MM, 200 ASA, NO ATTACHMENTS

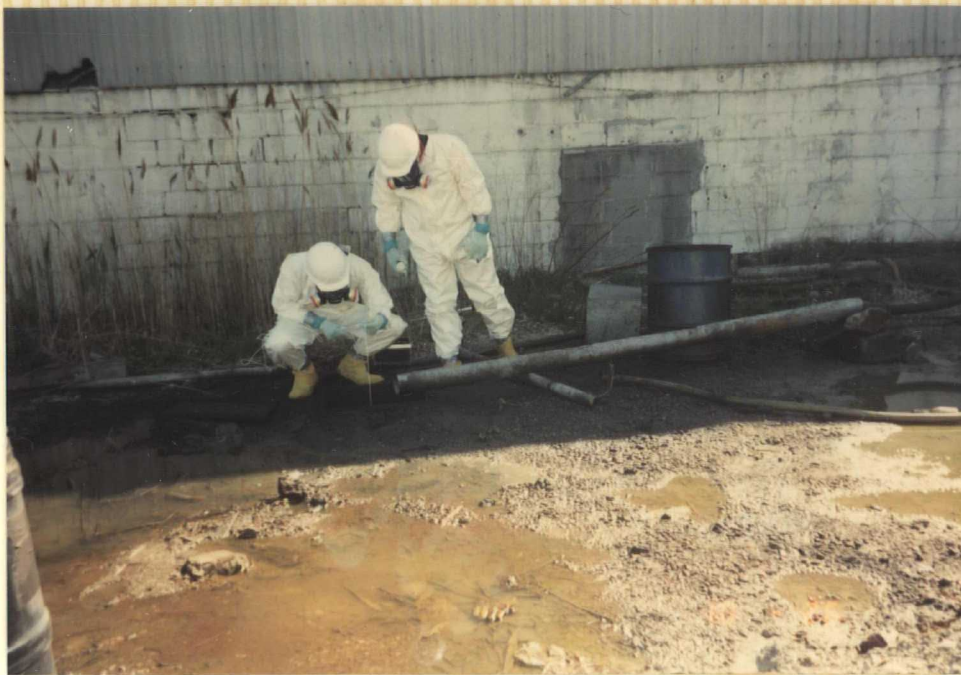
PHOTO: 9 PCS# 2704
 ROLL/PICTURE: 1/16
 SITE NAME: HENDERSHOT & SMITH, INC.
 DESCRIPTION: SAMPLING QUENCH OIL FROM UST, BAILER ON
 ROPE, LEVEL C, OIL SOAKED GROUND.
 DATE/TIME: 4-23-90 / 1030
 PHOTOGRAPHER: FINCH
 FILM: 35MM, 200 ASA, NO ATTACHMENTS

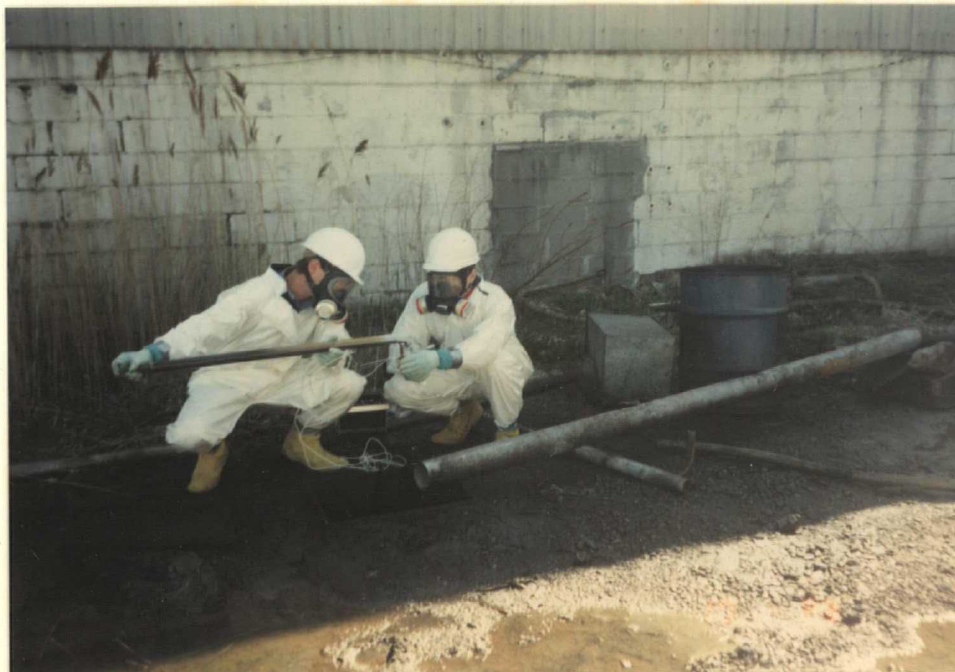
PHOTO: 10 PCS# 2704
 ROLL/PICTURE: 1/18
 SITE NAME: HENDERSHOT & SMITH, INC.
 DESCRIPTION: SAMPLING OIL FROM UST W/BAILER ON ROPE,
 FILLING 120 ML GLASS JAR, LEVEL C, CGI.
 DATE/TIME: 4-23-90 / 1035
 PHOTOGRAPHER: FINCH
 FILM: 35MM, 200 ASA, NO ATTACHMENTS
